Manhole Inspection Summary

Manhole # S45K__029MH

Insp Date: **7/23/08 2:51 PM**

Location Address: **1747 S Ann St**

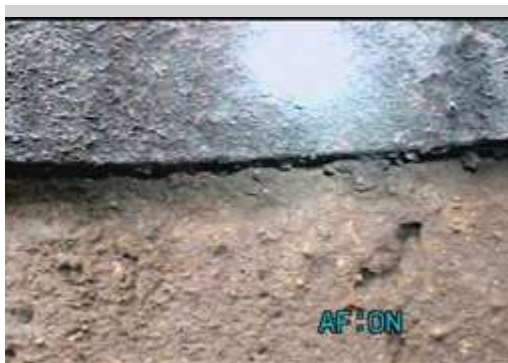
Defect 3

Condition: ☐ Sound ☐ Cracked ☐ Root Intrusion ☐ Loose Brick ☒ **Deteriorated**

chimney cond deteriorated

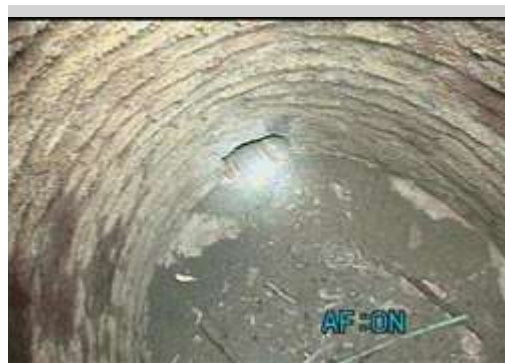
Defect 2

Condition: ☐ Sound ☐ Cracked ☐ Root Intrusion ☐ Deteriorated ☐ Leaks ☒ **Debris**

channel debris

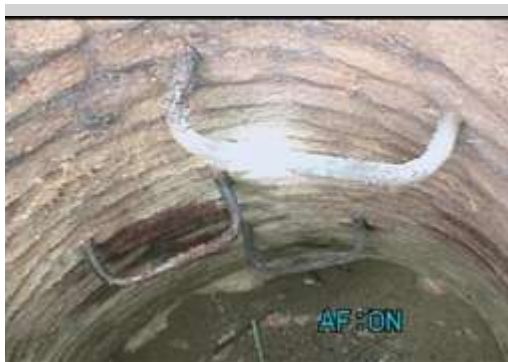
Defect 1

Count: **3** Missing: **0** ☒ **Corroded**

steps

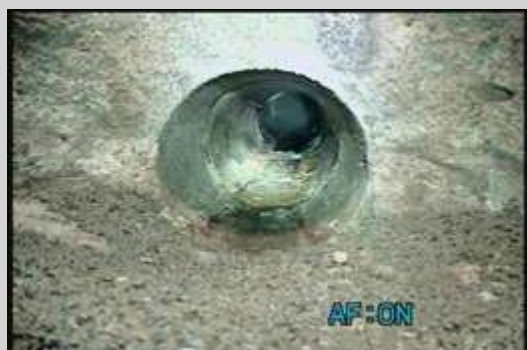
12 O'Clock Outflow

8 in. Circular Gravity Sewer
Pipe Out @ 12 O'Clock

Pipe Material: **Clay** ☐ Pipe Lined

Deposits: ☒ None ☐ Mud ☐ Sludge ☐ Debris ☐ Grease

Infiltration: **None** Pipe Seal Cond: **Unknown**
